North Merritt Island H&H Modeling Study Report

June 2022

This project involves the development of an integrated surface water-groundwater (SW-GW) model (ICPR4) for the NMI watershed. The completed model will yield results for analysis of current and future flooding conditions and will serve as a base model to evaluate potential flood control and natural system improvement projects and other physical changes to watershed. The model will also consider historical conditions in the IRL and Banana River as boundary conditions for the NMI watershed.

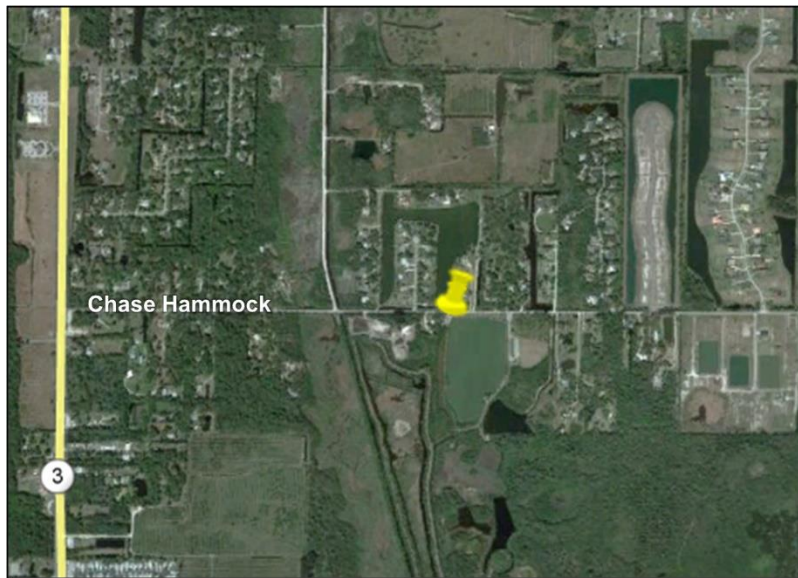
Figure 2.4: SJRWMD Well Location

2.4.1 SJRWMD Gage Data: Gage data was obtained from the SJRWMD Upper Floridan Aquifer Well located at Kings Park in Merritt Island (ID: BR2115). Data was collected for the surficial aquifer (POR 3/12/2009-8/11/2020) and for the upper Floridan (POR 12/4/1985-8/11/2020). See [Figure 2.4](#).
